PEDESTRIAN FOOTBRIDGE VERTICAL ACCESS OPTIONS

THE CITY OF
CHEBOYGAN

DECEMBER 21, 2022
HRC Job No. 20210958

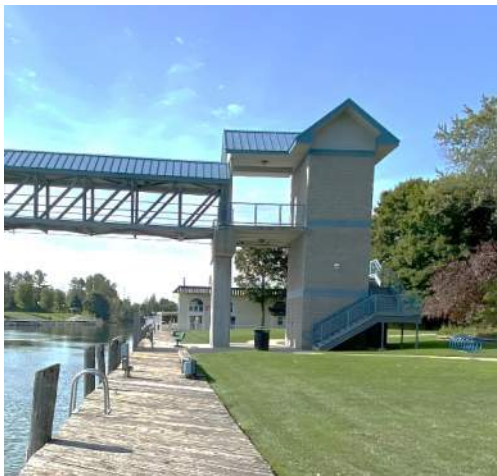
Second Floor landing is supported by CMU wall of elev/stair tower.
