PEDESTRIAN FOOTBRIDGE VERTICAL ACCESS OPTIONS

THE CITY OF
CHEBOYGAN

DECEMBER 21, 2022
HRC Job No. 20210958

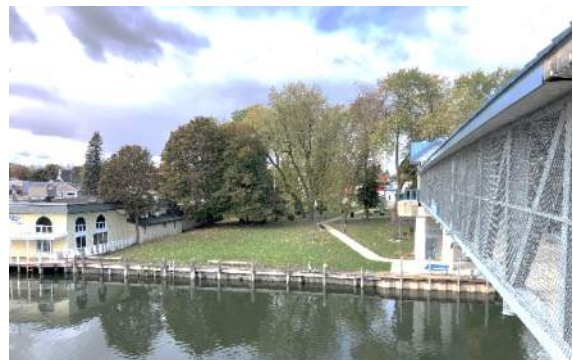
- In Washington Park, locating a ramp along the south side of the property is the most cost effective placement. There is open space and no known major underground utilities in the area. This will require the relocation of some park tables, sidewalk and lighting bollards but these are not overly costly impacts to the project. Some trees will likely need to be removed to allow construction for the ramp.

Washington Park - Recommended ramp location, south side of the property.

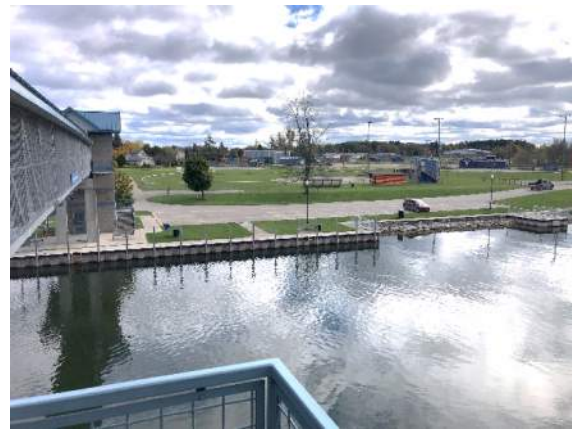
- In Major City Park, locating a ramp along the north side of the park may be desirable from the perspective that it does not impact the built facilities already present to the south. The potential conflict with the buried natural gas piping and telephone cables make this location challenging though. Assuming that the City does not acquire any additional property to the north and that the utilities are a conflict, then placing a compact layout ramp, south of the bridge, is the most cost effective placement. Parking areas, sidewalk and some site storm/underground electrical work will be necessary to accommodate this location.

Major City Park – Recommended ramp location, south of the elev/stair tower.

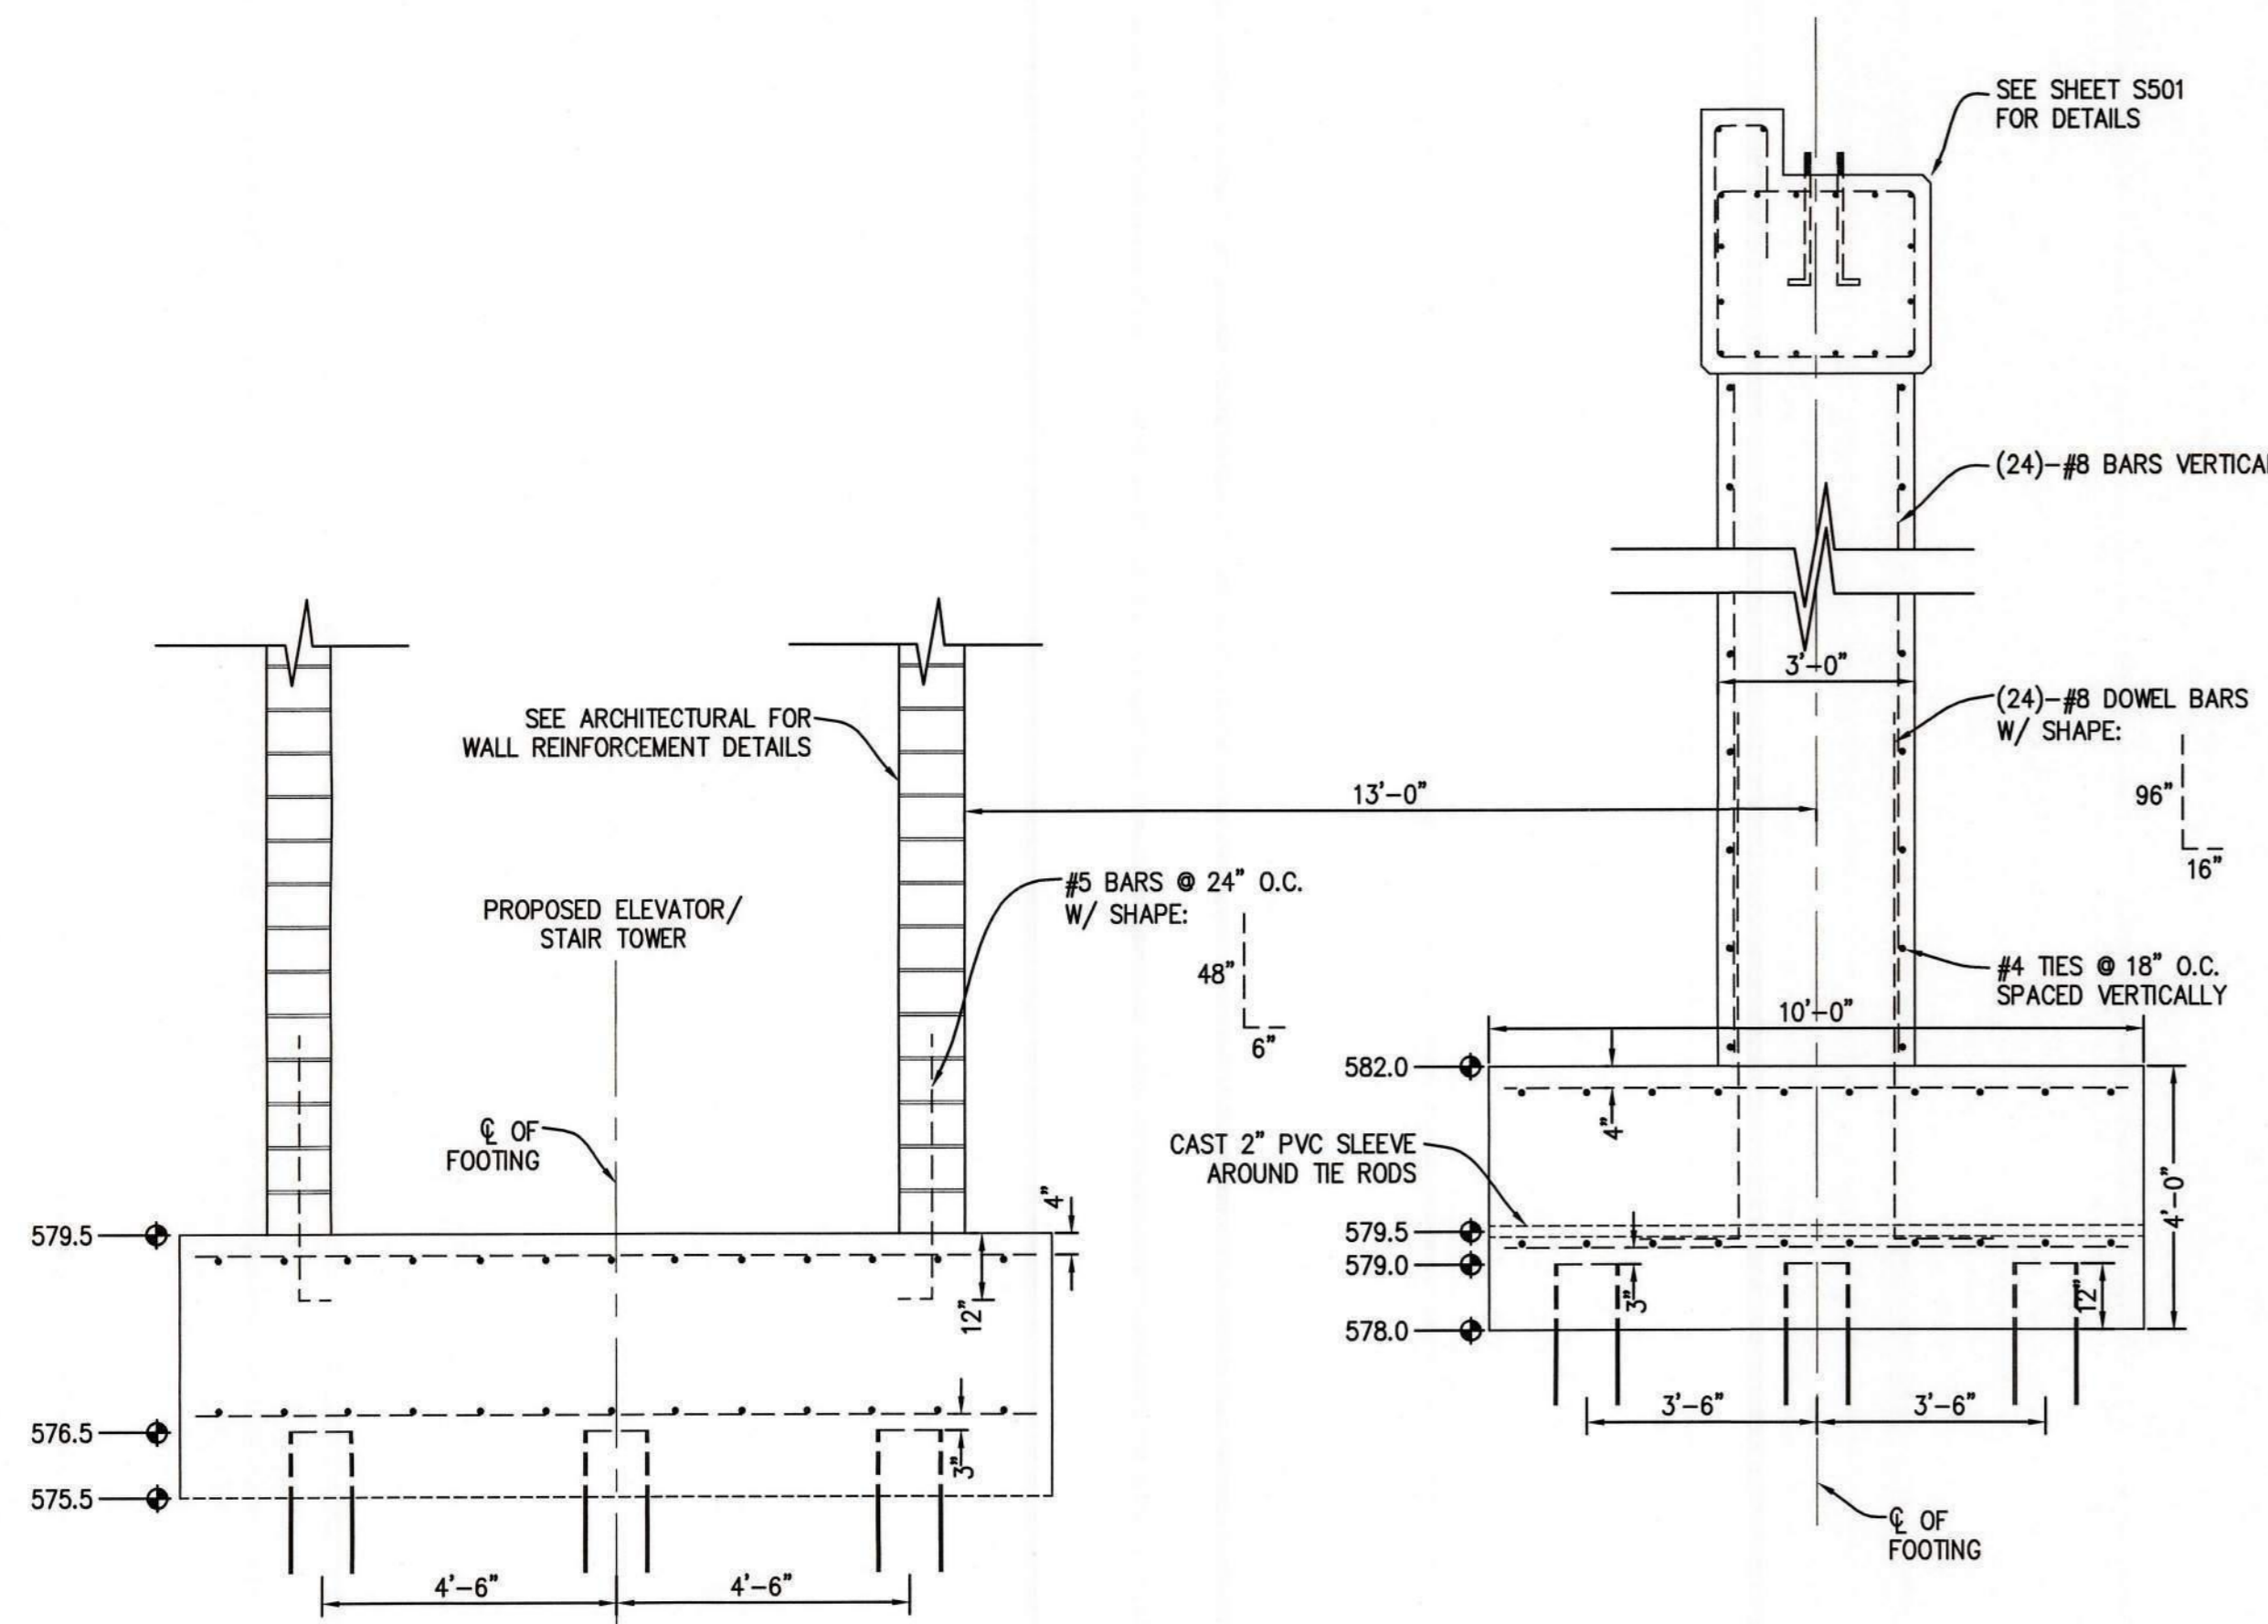
C1 WEST SIDE FOOTING SECTION
SCALE: 3/8" = 1'

the pit foundations were designed as shown on the Drawings. Because the City indicated that leakage into the pits has been on-going for years, (prior to the 2021 waterproofing attempt), we have to assume that there is either no exterior waterproofing or, if there is waterproofing, it was rendered ineffective overtime, as the water levels in the River rose higher and the ground around the foundation CMU became saturated.

As noted prior, the bottom of the elevator pit is the top of the concrete pile cap. This structure is shown to be elevation 579.50. The water level in the River is shown as "Varies" but lake levels have been recorded as high as elevation 582.81 in July, 2020 according to NOAA data from the Mackinaw City Weather Station. The soil borings used for the west side structure design data were drilled in May 1981 and indicated ground water encountered at elevation 576.30, approximate 28 years prior to construction.
